HYDROLOGIC RECONNAISSANCE OF
POINT REYES NATIONAL SEASHORE AREA, CALIFORNIA

Prepared in cooperation with the
National Park Service
U.S. Department of the Interior

OPEN-FILE REPORT

By
R. H. Dale and S. E. Rantz

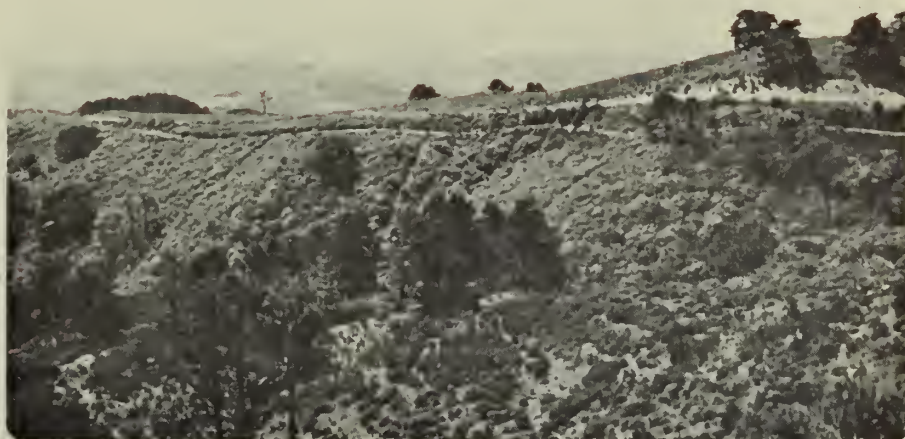
Figure 3.--View looking west from the summit of Drakes Summit Road (3N/9W-34). The upper basin of Laguna Creek is in the foreground; the low terrace is in the midground; and Point Reyes is in the background. This photo is taken in the saddle between Point Reyes Hill and Mount Wittenberg.

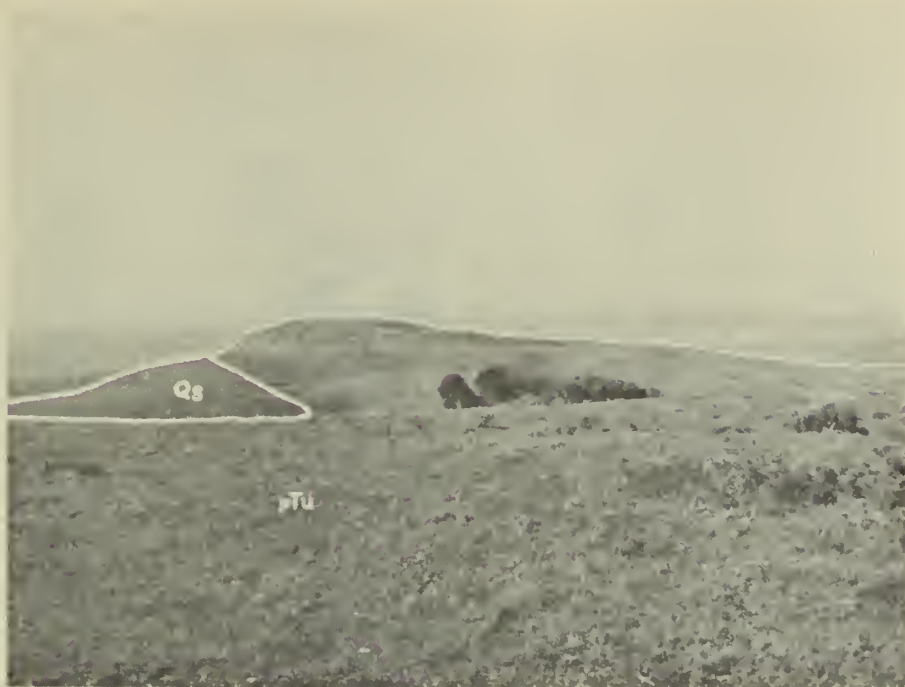
Figure 4.--View of Tomales Point looking northwest from BM 534 (4N/10W-15). The high wave-cut terrace is typical of the northern part of Inverness Ridge. Sand (Qs) lies on the basement complex (pTu) and forms the excellent reservoir that supplies McClure Creek. Trees in the midground mark the location of the Upper Pierce Ranch.

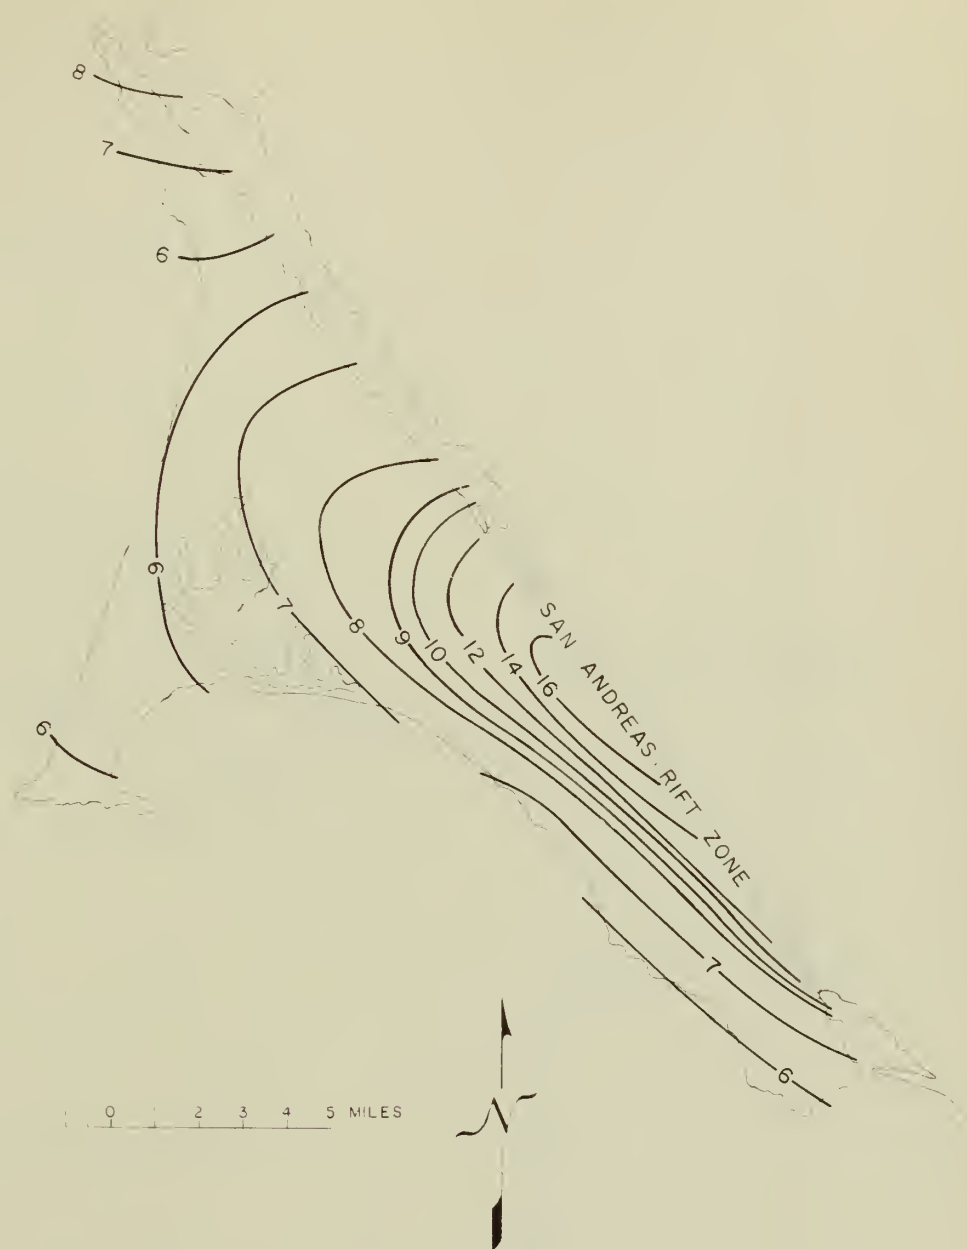
FIGURE 6.-RUNOFF MAP

CONTOURS ARE ISOPLETHS OF AVERAGE ANNUAL RUNOFF, IN INCHES

The areal distribution of precipitation is reflected in the areal pattern of runoff, values of which range from 6 to 16 inches. The isopleths of mean annual runoff shown on figure 6 are based on the rainfall distribution shown on figure 5 and on a rainfall-runoff relation for the surrounding area. There are no stream-gaging stations in the study area, but on the basis of streamflow records for nearby areas, it is estimated that about 90 percent of the annual runoff occurs during the 5 months, December through April.

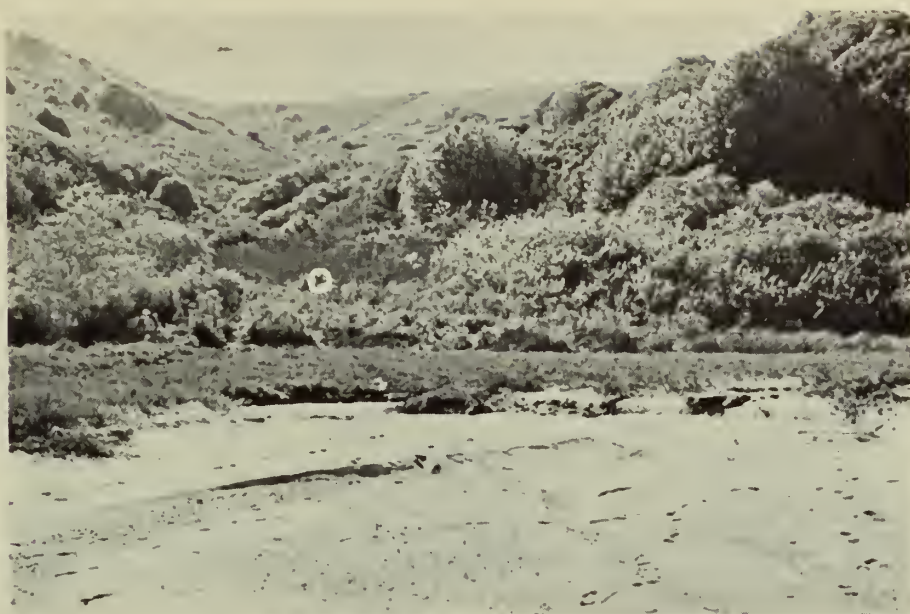
Figure 12.--The northernmost alluvial valley at Tomales Beach. The mouth of the valley is 120 feet wide. A well drilled at the location indicated by the circle probably will penetrate basement complex at less than 50 feet below land surface and probably will produce about 5 gpm. There is no perennial stream in this valley.

Sand and gravel.--This unit occurs in significant amounts in the stream valleys of the low-terrace area (fig. 11). It also occurs in discontinuous patches along the San Andreas Rift Zone. Extremely small amounts also occur in the stream valleys on the east side of Inverness Ridge in and north of the town of Inverness (fig. 12).

9. Tomales Beach (Marshall property).--The alluvial sand and gravel is thin at this site. A well in the second alluvial valley north of Laird's Landing (figs. 10 and 12), about 20 feet above sea level, may yield about 5 gpm. If additional water is required, a well could be drilled in the marine sandstone about three-fourths of a mile southwest of the beach. There is no summer surface flow at Tomales Beach.
